This service note provides instructions for retrofitting the power and data harness in your IRIDEON[®] AR500[™] exterior luminaire. Which retrofit kit you use depends on the type of AR500 luminaire you are servicing, standard or remote. Use retrofit kit 7091K1001 for an AR500 standard luminaire retrofit. Use retrofit kit 7091K1001-1 for an AR500 remote luminaire retrofit. Additional instructions are provided for replacement of the 9pin CPC connector and contact pins if required. This retrofit requires you to open and work inside your AR500[™] luminaire stanchion.

Service Note:

IRIDEON® AR500™ Harness Retrofit

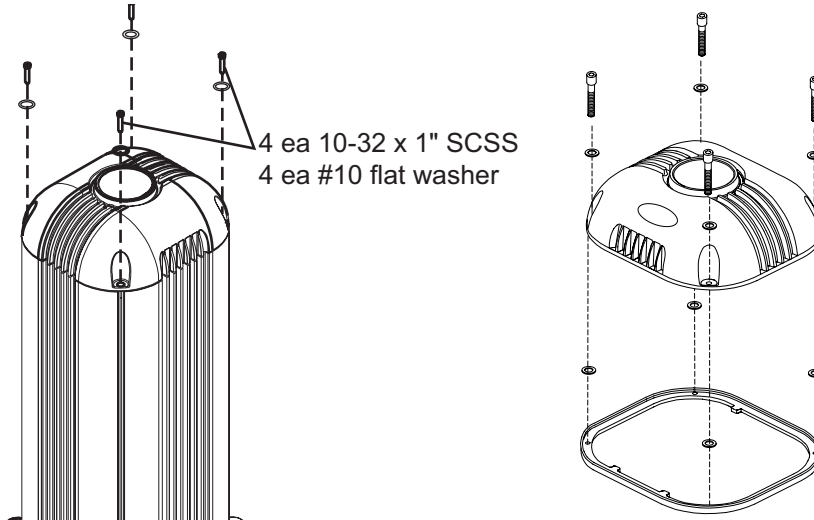
Step 1: Remove the AR500 stanchion cover by unscrewing the four Allen head screws. Remove the stanchion cap, gasket and all hardware.

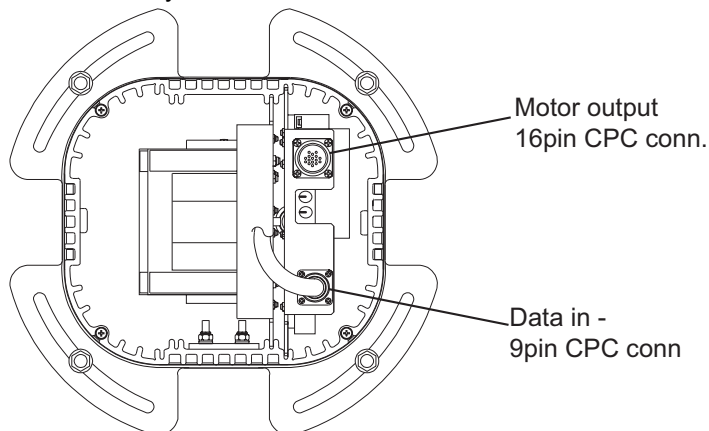
Step 2: Disconnect the two CPC connectors, motor output and data input, from the control electronics tray.

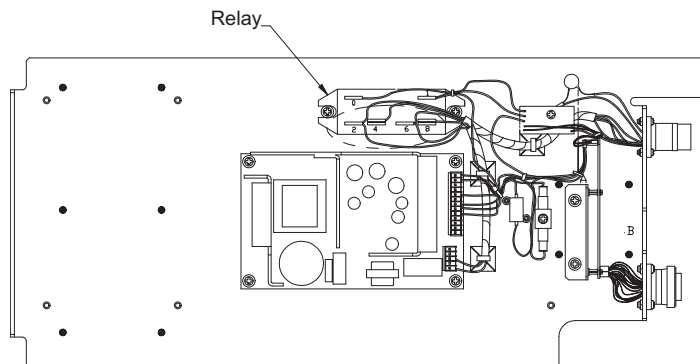
Step 3: Remove the control electronics tray from the stanchion.

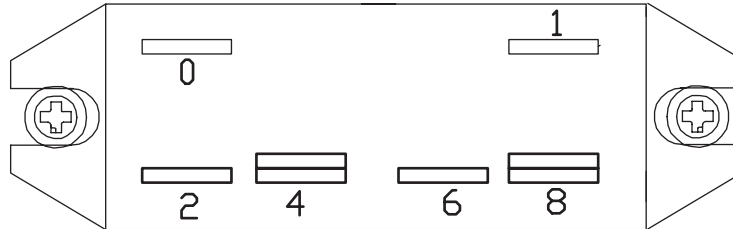
- Step 7: Disconnect the terminal wires 2, 4, 6 and 8 from the relay.

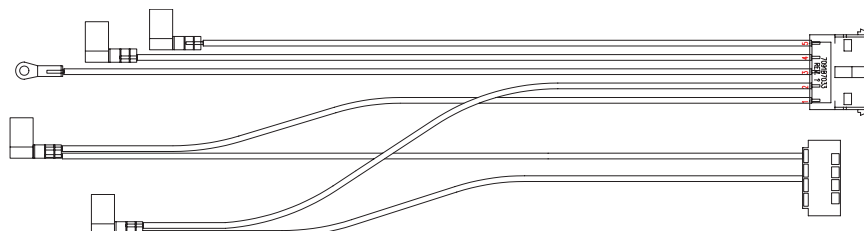
- Step 10: At this point the old AC Power Harness will be free, you can discard this cable assembly and find the new Control Plate AC Power Harness (ETC Part Number 7091B7033) from the kit provided.

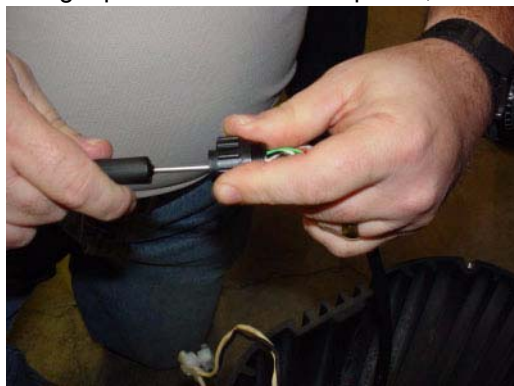
Step 8: Using a pin extractor remove pins 1, 6-9 from the 9pin CPC connector.

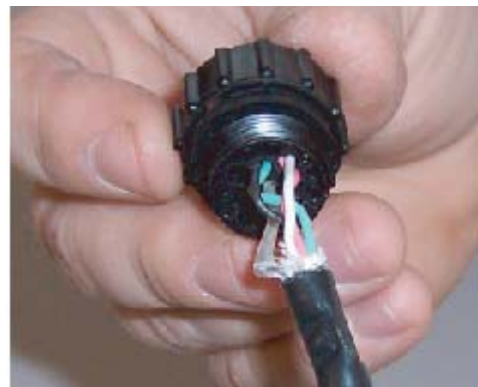
Step 9: Remove the loosened cables from the connector leaving only the data wires in the connector.

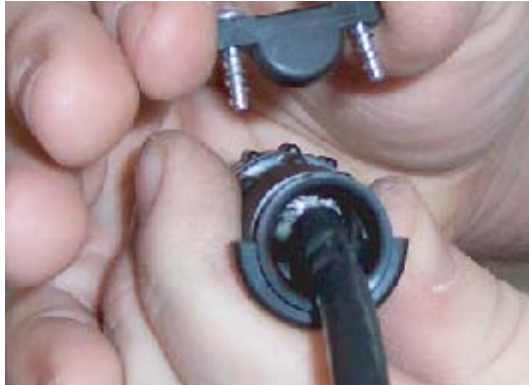
Step 11: Invert the strain relief and secure with the two screws provided until snug.

Note: *Do not overtighten the strain relief.*

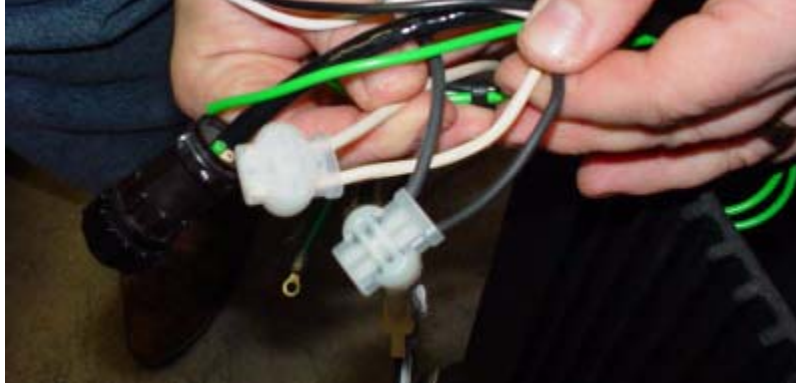
- Step 15: Using two scotchlok wire connectors (ETC Part Number J4166) provided, attach the black and white AC wires from the stanchion AC power harness to the black and white incoming AC power wires in the stanchion.

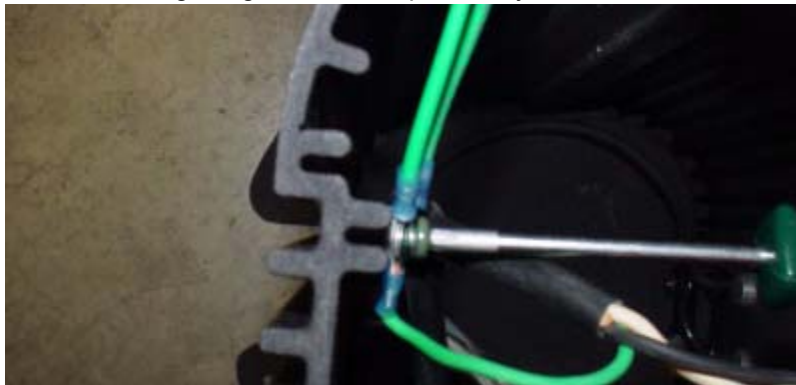
- Step 16: Find the three ground wires with the ring terminals and attach them to the inside of the stanchion using the ground screw previously removed.

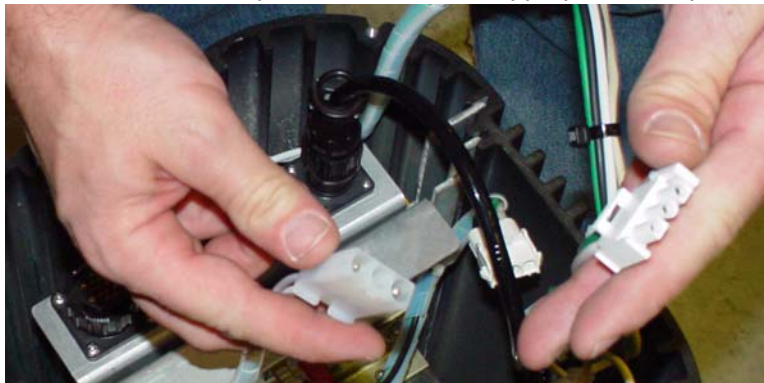
- Step 1: For AR500 standard luminaires, reinstall the ballast and control electronics tray into the stanchion. For AR500 remote luminaires, reinstall the control electronics tray into the stanchion.
- Step 2: Connect all data and power cables to the appropriate receptacles.

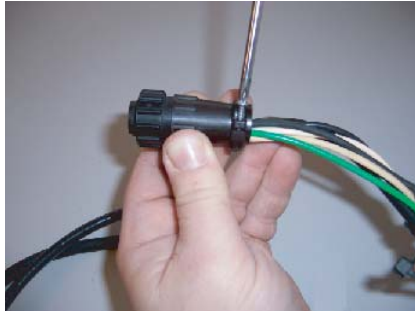
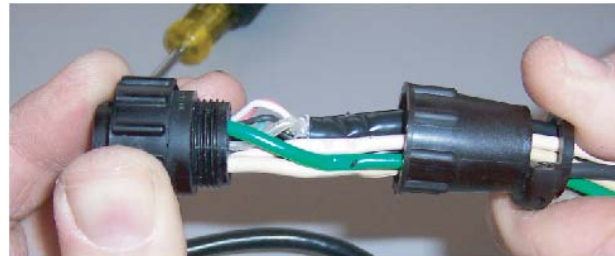
Step 1: Release the strain relief and backshell from the 9pin CPC connector.

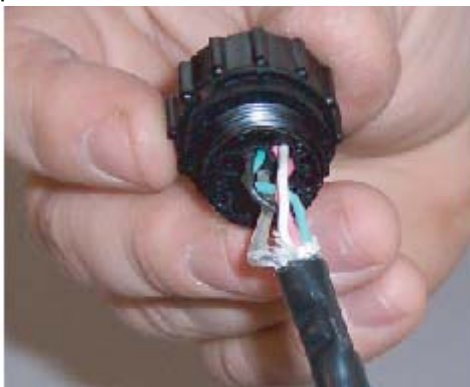
Step 5: Insert **only the data** contact pins into the replacement 9pin CPC connector following the pinout below.

| PIN # | Wire type |
| 5 | Shield (w/ heat shrink) |
| 3 | Data + (red/white) |
| 2 | Data - (green/black) |

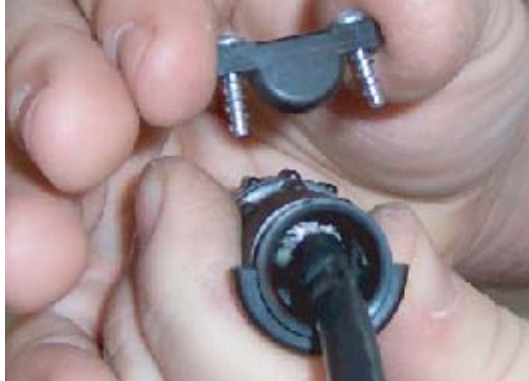
Step 7: Invert the strain relief and secure with the two screws provided until snug.

Note: Do not overtighten the strain relief.

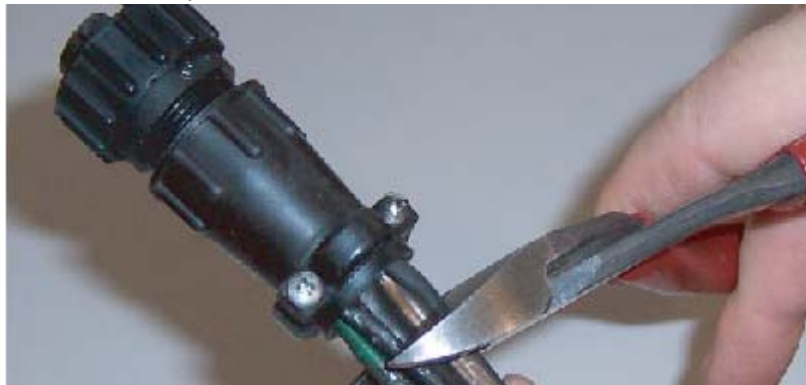
Step 1: Cut the entire 9pin CPC connector off the cable.

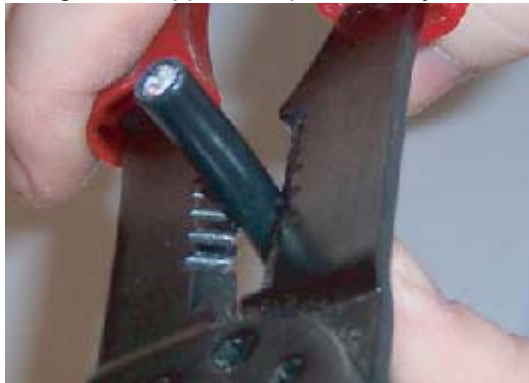
Step 2: Using wire strippers, strip the outer jacket of the data cable back 1”.

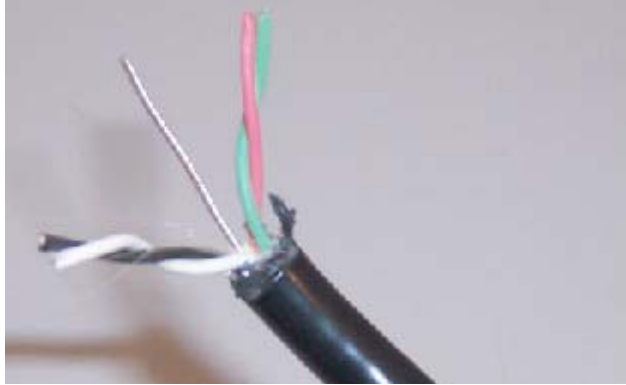
Step 3: Carefully separate and trim back the braided shield from the wires.

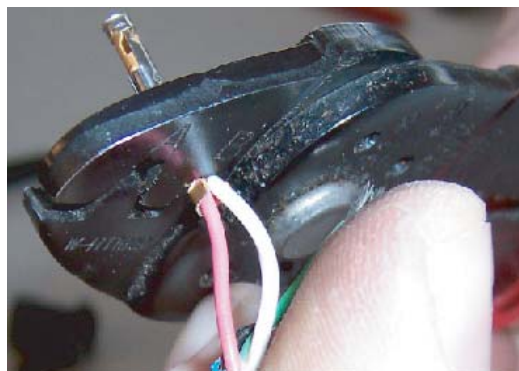
Step 10: Twist the Red and White **bare wire** together and insert one contact pin around the wire pair.

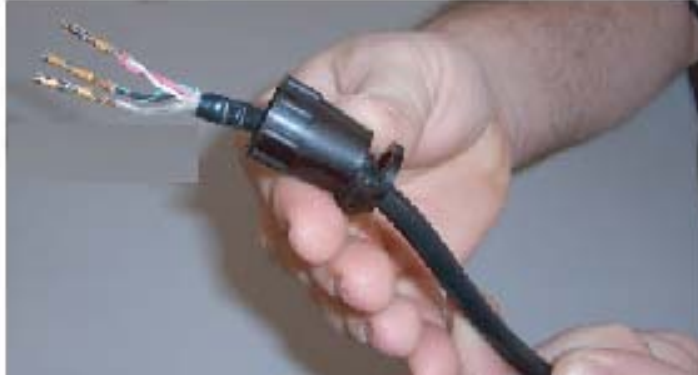
- Step 13: Twist the Green and Black bare wire together and insert one contact pin around the wire pair.
- Step 14: Crimp until secure.
- Step 15: Crimp the strain relief around the wire sheathing.

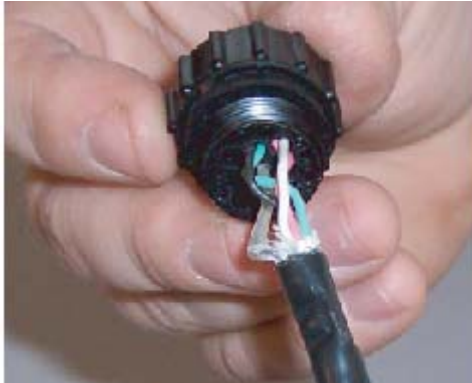
- Step 16: Insert the data contact pins into the new 9pin CPC connector following the pin out below.

| PIN # | Wire type |
| 5 | Shield (w/ heat shrink) |
| 3 | Data + (red/white) |
| 2 | Data - (green/black) |

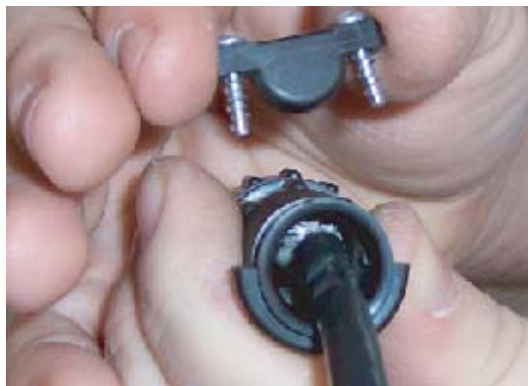
- Step 17: Reinstall the backshell to the new connector.
- Step 18: Invert the strain relief and secure with the two screws provided until snug.

Note: Do not overtighten the strain relief.
